Manhole Inspection Summary

Manhole # S19EE2003MH

Location Address: **5701 NEWBURY ST**

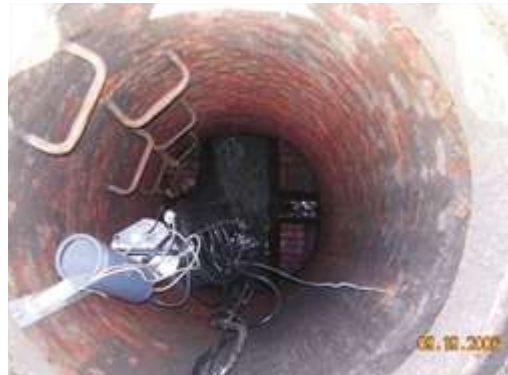
Top View

Barrel infiltration. Evidence of surcharge - Bench debris. Corroded steps.

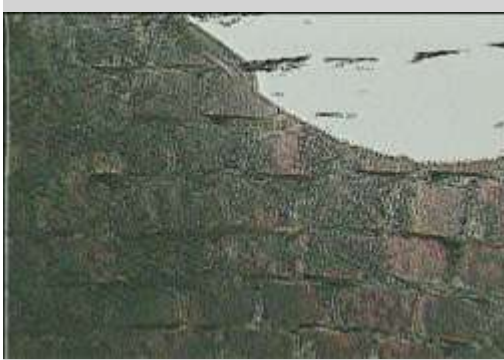
Defect

Adjustment and Corbel deterioration and infiltration.

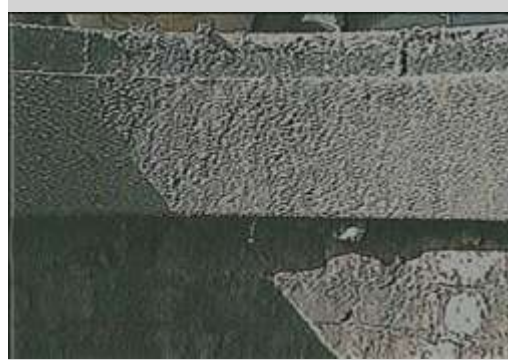
Defect

Frame leaks. Adjustment deterioration and infiltration.

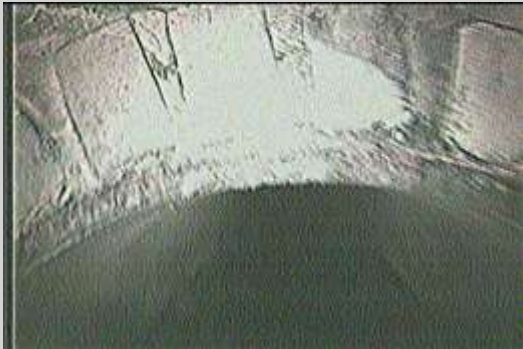
24 in. Circular Gravity Sewer Pipe Out @ 12 O'Clock

Infiltration: **Evidence** Pipe Seal Cond: **Unknown**

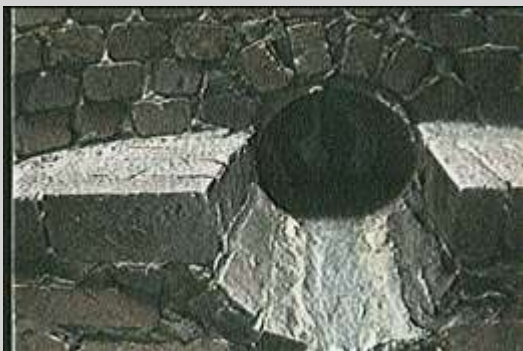
10 in. Circular Gravity Sewer Pipe In @ 3 O'Clock

Barrel deterioration and infiltration. Channel deterioration.

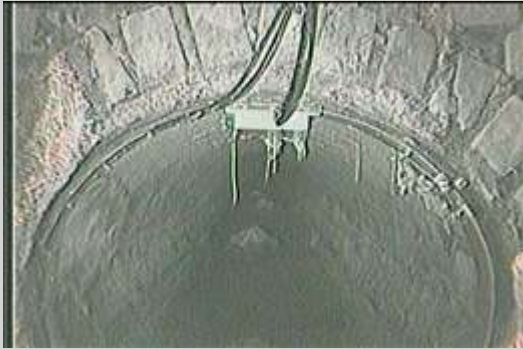
24 in. Circular Gravity Sewer

Infiltration: **Evidence** Pipe Seal Cond: **Cracked**

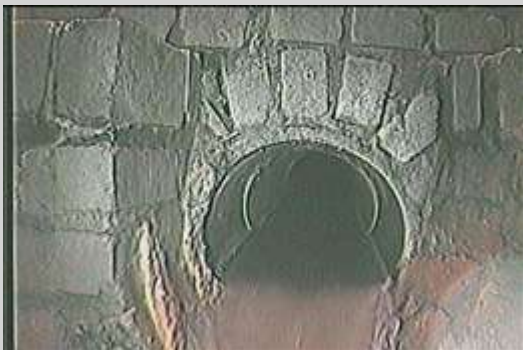
10 in. Circular Gravity Sewer

Infiltration: **Evidence** Pipe Seal Cond: **Unknown**
